# Manhole Inspection Summary

Manhole # S31AA2009MH

Insp Date: **4/17/07 9:22 AM**

**Location** Address: **115 TAPLOW RD**

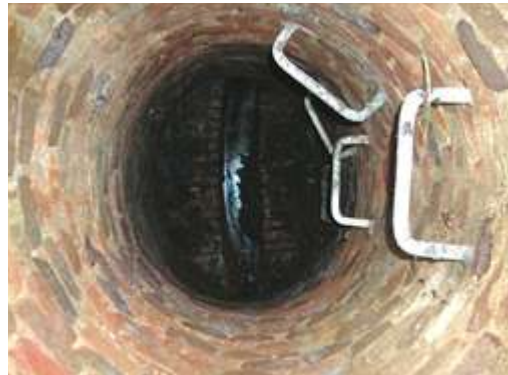
Top View

**Surcharge** ☒ **Evidence Of Surcharge** Depth: **1.5** (ft.) ☐ Active Surcharge Present

Evidence of surcharge - Bench debris.  
Channel debris.

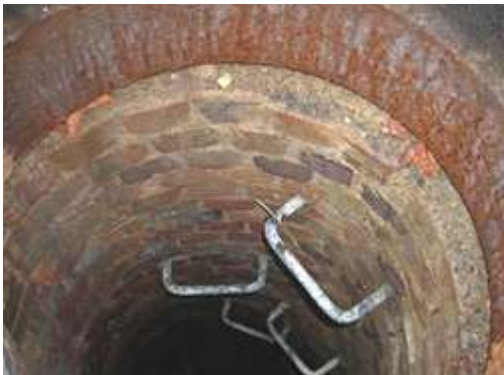
Defect

**Frame** Offset: **1** (in.) Condition: ☐ Sound ☐ Cracked ☒ **Leaks**

Condition: ☐ Sound ☐ Cracked ☐ Root Intrusion ☐ Loose Brick ☒ **Deteriorated**

Infiltration: ☐ None ☒ **Joint** ☐ Cracks ☐ Mortar ☐ Roots ☒ **Wall**

Frame leaks. Adjustment deterioration  
and infiltration. Barrel infiltration.

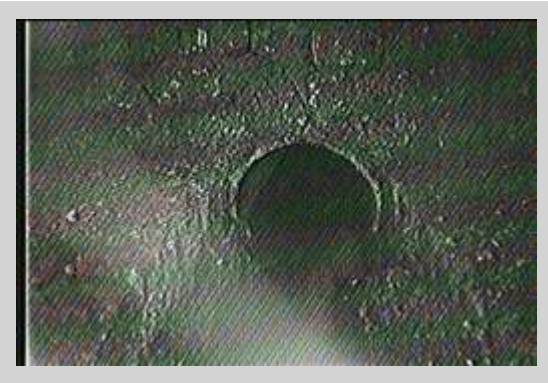
Pipe Out @ 12 O'Clock

Condition: ☐ Sound ☐ Cracked ☐ Root Intrusion ☐ Loose Brick ☒ **Deteriorated**

Infiltration: ☐ None ☐ Joint ☐ Cracks ☒ **Mortar** ☐ Roots ☐ Wall

Barrel deterioration and infiltration.

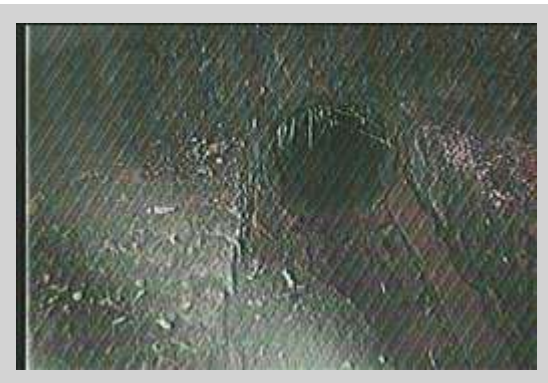
Pipe In @ 5 O'Clock

Condition: ☐ Sound ☐ Cracked ☒ **Root Intrusion** ☐ Deteriorated ☐ Leaks ☐ Debris

Channel root intrusion.

Infiltration: **None** Pipe Seal Cond: **Roots**
